Flood Control Project Maintenance
2016 Structure Summary Report
Overall Unit and Item Ratings

Sacramento County

American River Pumping Plant No. 1 Howe Avenue Storm Drain D - 05

Flood Control Project Maintenance
Unit Cover Sheet
2016 Pumping Plant Inspection Results

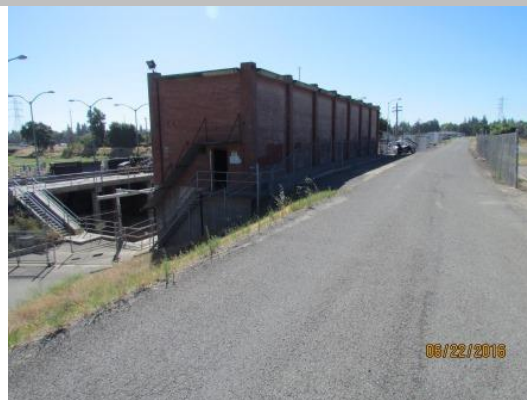
Photo 1 of 2 : ST_2016_NA0050_13_3_20160627_00024.jpg

LM Start	0.00	Rating **	A	Issue No.	3	
LM End	0.00	Issue Type +	Ma	Location *		
Category	Pump Stations			GPS Latitude/Longitude		
				Start	End	
Item	Plant Building			38.584600 °	38.584600 °	
				-121.421417 °	-121.421417 °	
DWR ID	DWR_NA0050_13_t_2012_3					
Action/Comments						
Inspector Comments: This facility is under construction. Plant building appears to be in sound structural condition.

View of the pump building.

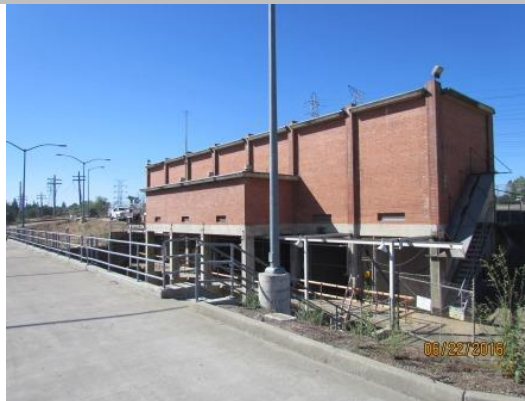
Photo 2 of 2 : ST_2016_NA0050_13_3_20160627_00026.jpg

LM Start	0.00	Rating **	A	Issue No.	3 (cont)	
LM End	0.00	Issue Type +	Ma	Location *		
Category	Pump Stations			GPS Latitude/Longitude		
				Start	End	
Item	Plant Building			38.584600 °	38.584600 °	
				-121.421417 °	-121.421417 °	
DWR ID	DWR_NA0050_13_t_2012_3					
Action/Comments						
Inspector Comments: This facility is under construction. Plant building appears to be in sound structural condition.

Another view of the pump building.

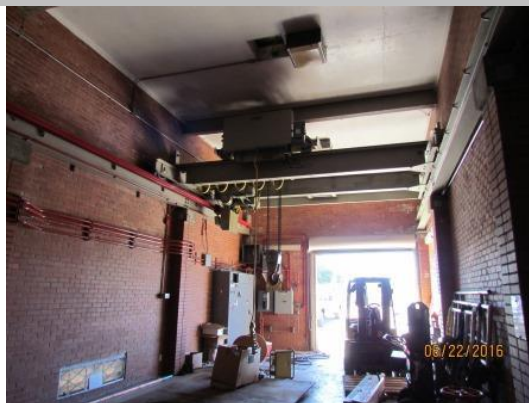
Photo 1 of 1 : ST_2016_NA0050_13_6_20160627_00027.jpg

LM Start	0.00	Rating **	A	Issue No.	6	
LM End	0.00	Issue Type +	Ma	Location *		
Category	Pump Stations			GPS Latitude/Longitude		
				Start		End
Item	Cranes			38.584600 °		38.584600 °
				-121.421417 °		-121.421417 °
DWR ID	DWR_NA0050_13_t_2012_6					
Action/Comments						
Inspector Comments: This facility is under construction. Cranes appear to be in operational condition.

View of the cranes inside the building.

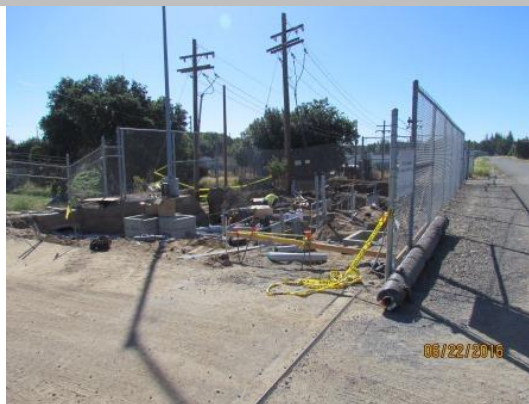
Photo 1 of 1 : ST_2016_NA0050_13_8_20160627_00028.jpg

View of the future location of the power generator.

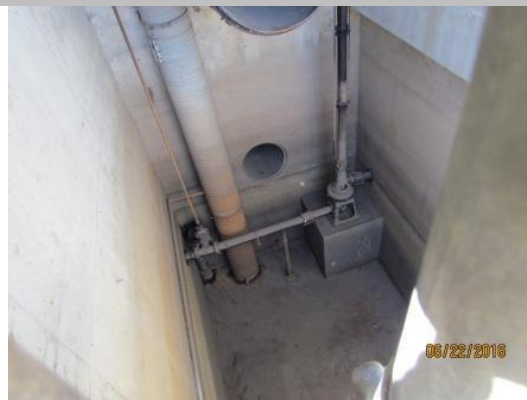
Photo 1 of 1 : ST_2016_NA0050_13_12_20160627_00029.jpg

Typical view of the wet well.

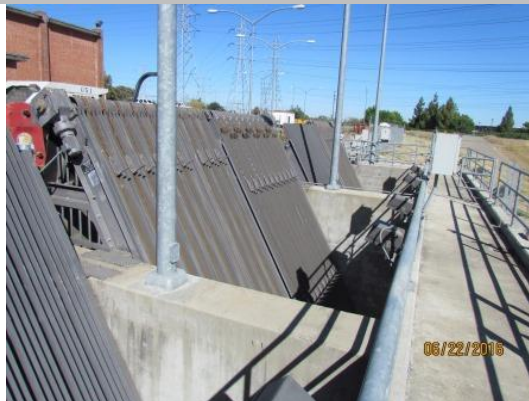
Photo 1 of 3 : ST_2016_NA0050_13_13_20160627_00033.jpg

View of the trash racks at the inlet.

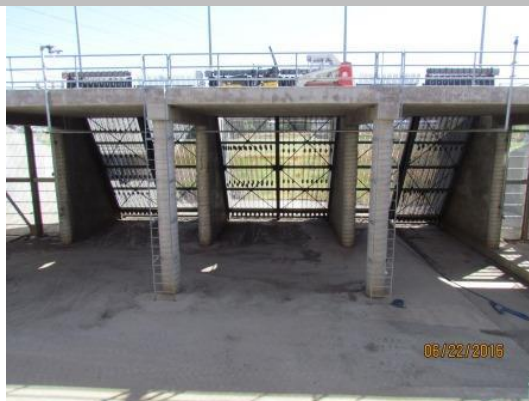
Photo 2 of 3 : ST_2016_NA0050_13_13_20160627_00034.jpg

Another view of the trash racks at the inlet.

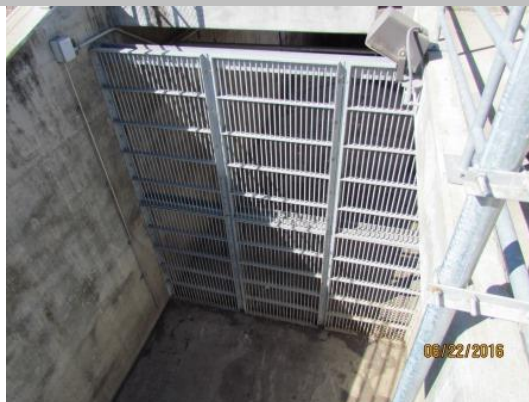
Photo 3 of 3 : ST_2016_NA0050_13_13_20160627_00030.jpg

View of the gate trash racks at the inlet.

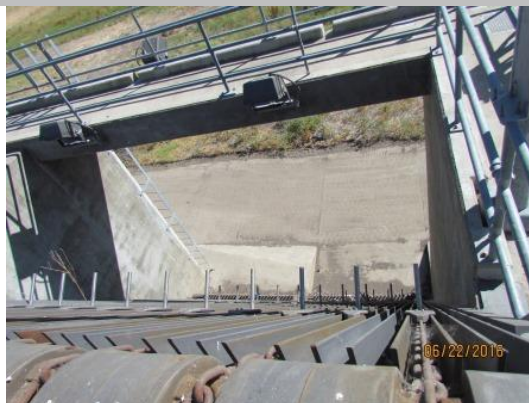
Photo 1 of 1 : ST_2016_NA0050_13_14_20160627_00035.jpg

LM Start	0.00	Rating **	A	Issue No.	14
LM End	0.00	Issue Type +	Ma	Location *	
Category	Pump Stations			GPS Latitude/Longitude	
				Start	End
Item	Trash Rakes			38.584600 °	38.584600 °
				-121.421417 °	-121.421417 °
DWR ID	DWR_NA0050_13_t_2012_14				
Action/Comments					
Inspector Comments: This facility is under construction. Trash rake appears to be properly maintained and in operational condition.

Close up photo of trash rake, note cleanliness and free of debris.

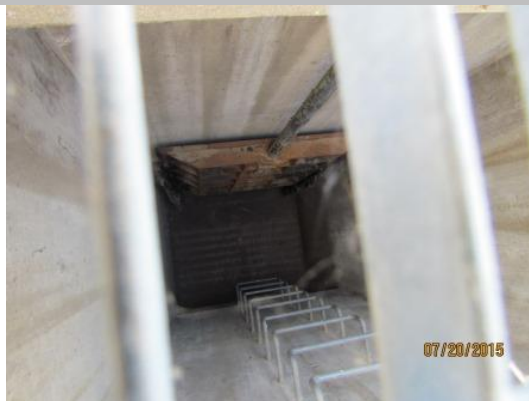
Photo 1 of 1 : ST_2016_NA0050_13_15_20160615_00017.jpg

LM Start	0.00	Rating **	A	Issue No.	15
LM End	0.00	Issue Type +	Ma	Location *	
Category	Pump Stations			GPS Latitude/Longitude	
				Start	End
Item	Sluice / Slide Gates			38.584600 °	38.584600 °
				-121.421417 °	-121.421417 °
DWR ID	DWR_NA0050_13_t_2012_15				
Action/Comments					
Inspector Comments: This facility is under construction. Slide gates appear to be in good operational condition.

View of the slide gate, typical.

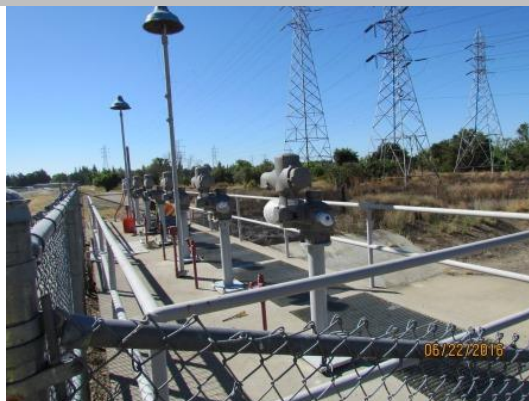
Photo 1 of 2 : ST_2016_NA0050_13_16_20160627_00036.jpg

LM Start	0.00	Rating **	A	Issue No.	16
LM End	0.00	Issue Type +	Ma	Location *	
Category	Pump Stations			GPS Latitude/Longitude	
				Start	End
Item	Electric Gate Operators			38.584600 °	38.584600 °
				-121.421417 °	-121.421417 °
DWR ID	DWR_NA0050_13_t_2012_16				
Action/Comments					
Inspector Comments: This facility is under construction. Electric gate operators appear to be in proper operating condition.

View of the gate operators

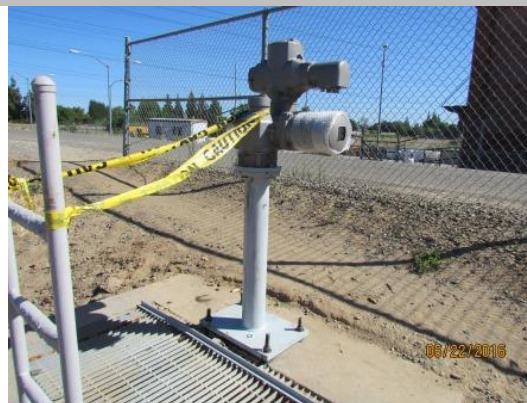
Photo 2 of 2 : ST_2016_NA0050_13_16_20160627_00037.jpg

LM Start	0.00	Rating **	A	Issue No.	16 (cont)	
LM End	0.00	Issue Type +	Ma	Location *		
Category	Pump Stations			GPS Latitude/Longitude		
				Start		End
Item	Electric Gate Operators			38.584600 °		38.584600 °
				-121.421417 °		-121.421417 °
DWR ID	DWR_NA0050_13_t_2012_16					
Action/Comments						
Inspector Comments: This facility is under construction. Electric gate operators appear to be in proper operating condition.

View of the gravity flow gate operator.

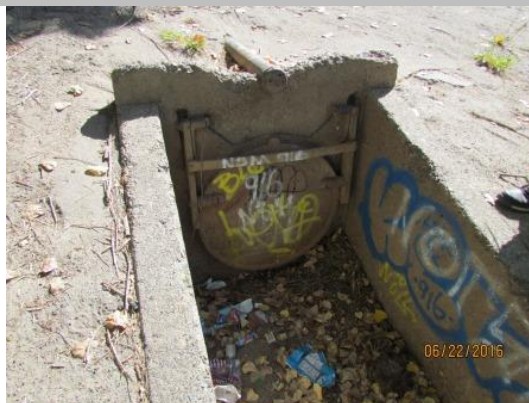
Photo 1 of 2 : ST_2016_NA0050_13_19_20160627_00039.jpg

View of the low flow flap gate.

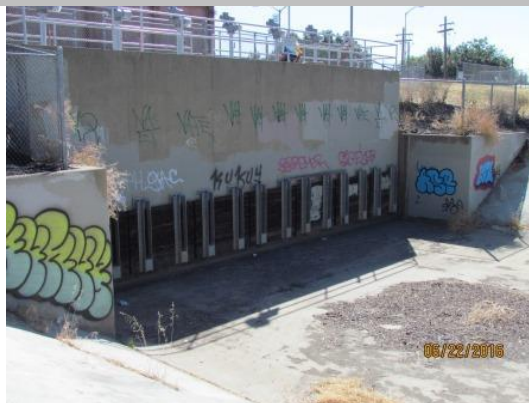
Photo 2 of 2 : ST_2016_NA0050_13_19_20160627_00038.jpg

View of the flap gates on the waterside.

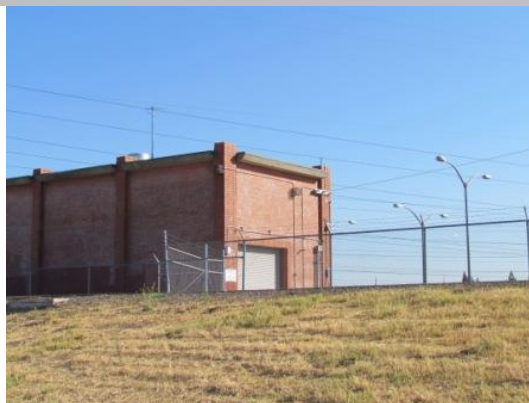
Photo 1 of 2 : ST_2016_NA0050_13_21_20160615_00022.jpg

View of the security fencing around the pumping facility.

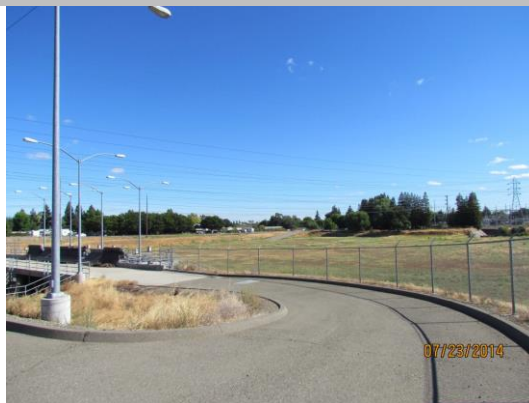
Photo 2 of 2 : ST_2016_NA0050_13_21_20160615_00023.jpg

View of the security fencing.

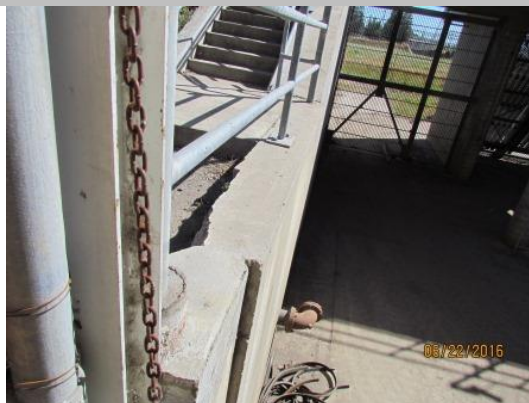
Photo 1 of 2 : ST_2016_NA0050_13_22_20160627_00041.jpg

LM Start	0.00	Rating **	A	Issue No.	22
LM End	0.00	Issue Type +	Ma	Location *	
Category	Pump Stations			GPS Latitude/Longitude	
				Start	End
Item	Intake and Discharge Pipes			38.584600 °	38.584600 °
				-121.421417 °	-121.421417 °
DWR ID	DWR_NA0050_13_t_2012_22				
Action/Comments					
Inspector Comments: This facility is under construction. Pipes do not appear to have breaks, corrosion, holes or cracks that would be a source of water leakage.

View of the wall displaced about 1.5 inches.

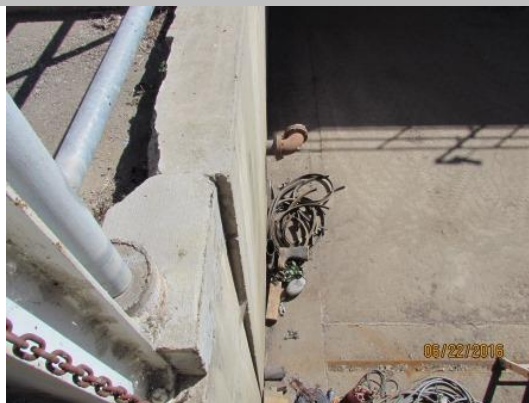
Photo 2 of 2 : ST_2016_NA0050_13_22_20160627_00040.jpg

LM Start	0.00	Rating **	A	Issue No.	22 (cont)	
LM End	0.00	Issue Type +	Ma	Location *		
Category	Pump Stations			GPS Latitude/Longitude		
				Start	End	
Item	Intake and Discharge Pipes			38.584600 °	38.584600 °	
				-121.421417 °	-121.421417 °	
DWR ID	DWR_NA0050_13_t_2012_22					
Action/Comments						
Inspector Comments: This facility is under construction. Pipes do not appear to have breaks, corrosion, holes or cracks that would be a source of water leakage.

Another view of the displaced wall. This issue does not appear to impede the designed operation of the pumping plant.

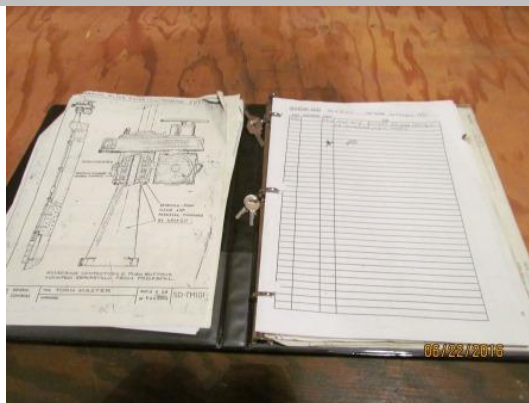
Photo 1 of 1 : ST_2016_NA0050_14_1_20160627_00015.jpg

Photo shows operating log on site.

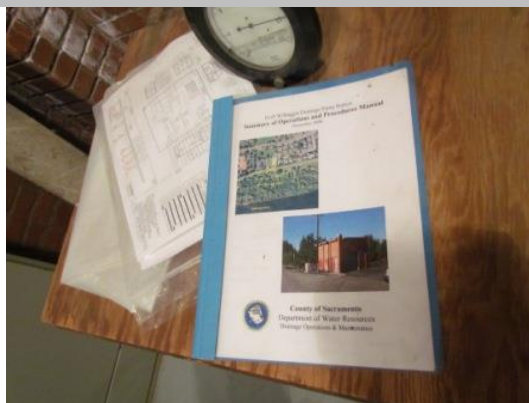
Photo 1 of 1 : ST_2016_NA0050_14_2_20160615_00002.jpg

LM Start	0.00	Rating **	A	Issue No.	2
LM End	0.00	Issue Type +	Ma	Location *	
Category	Pump Stations			GPS Latitude/Longitude	
				Start	End
Item	Operation & Maintenance Manual			38.569692 °	38.569692 °
				-121.374816 °	-121.374816 °
DWR ID	DWR_NA0050_14_t_2012_2				
Action/Comments					
Inspector Comments: O & M Manual is kept on site, posted instructions are also written on dry erase board.

Photo shows O&M manual on site.

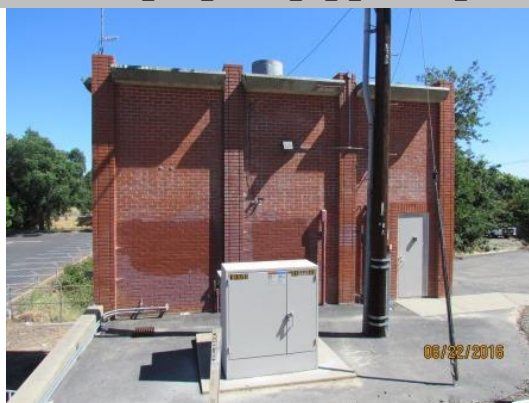
Photo 1 of 3 : ST_2016_NA0050_14_3_20160627_00016.jpg

LM Start	0.00	Rating **	A	Issue No.	3
LM End	0.00	Issue Type +	Ma	Location *	
Category	Pump Stations			GPS Latitude/Longitude	
				Start	End
Item	Plant Building			38.569692 °	38.569692 °
				-121.374816 °	-121.374816 °
DWR ID	DWR_NA0050_14_t_2012_3				
Action/Comments					
Inspector Comments: Building appears to be in sound structural condition.

View of the pumping plant building.

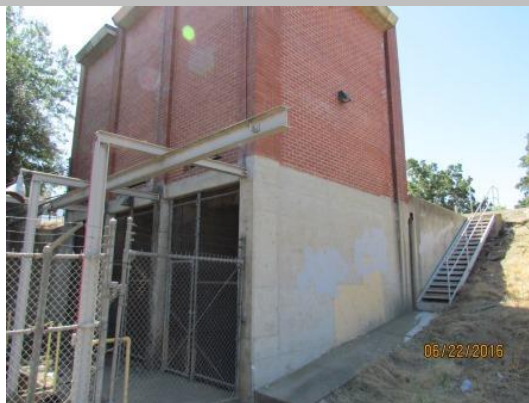
Photo 2 of 3 : ST_2016_NA0050_14_3_20160627_00027.jpg

LM Start	0.00	Rating **	A	Issue No.	3 (cont)	
LM End	0.00	Issue Type +	Ma	Location *		
Category	Pump Stations			GPS Latitude/Longitude		
				Start	End	
Item	Plant Building			38.569692 °	38.569692 °	
				-121.374816 °	-121.374816 °	
DWR ID	DWR_NA0050_14_t_2012_3					
Action/Comments						
Inspector Comments: Building appears to be in sound structural condition.

View of the wet wells and plant building.

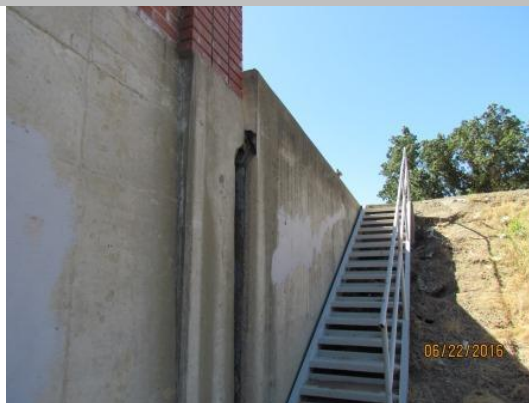
Photo 3 of 3 : ST_2016_NA0050_14_3_20160627_00028.jpg

View of the retaining wall displaced about 4 inches from the plant building. This issue does not appear to impede the designed pumping plant operation.

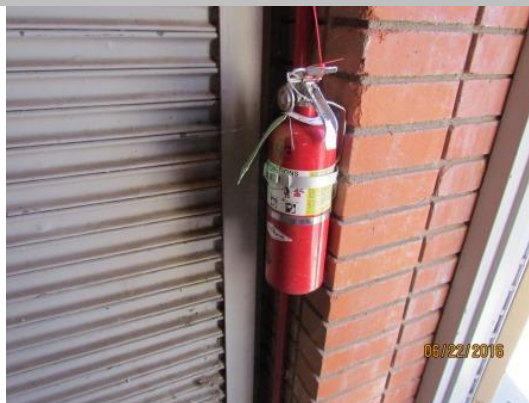
Photo 1 of 1 : ST_2016_NA0050_14_5_20160627_00017.jpg

LM Start		Rating **	A	Issue No.	5
LM End	0.00	Issue Type +	Ma	Location *	
Category	Pump Stations			GPS Latitude/Longitude	
				Start	End
Item	Safety			38.569692 °	38.569692 °
				-121.374816 °	-121.374816 °
DWR ID	DWR_NA0050_14_t_2012_5				
Action/Comments					
Inspector Comments: No safety hazards are visible.

View of the fire extinguisher mounted inside the pump building.

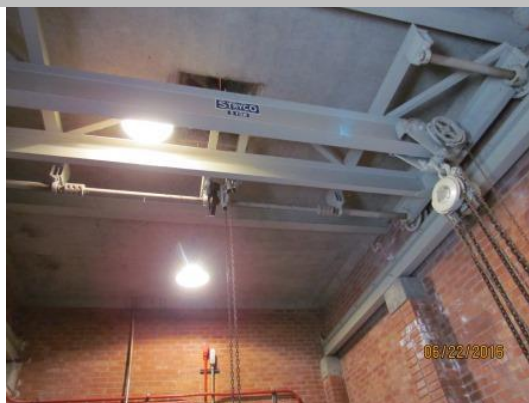
Photo 1 of 1 : ST_2016_NA0050_14_6_20160627_00018.jpg

LM Start	0.00	Rating **	A	Issue No.	6
LM End	0.00	Issue Type +	Ma	Location *	
Category	Pump Stations			GPS Latitude/Longitude	
				Start	End
Item	Cranes			38.569692 °	38.569692 °
				-121.374816 °	-121.374816 °
DWR ID	DWR_NA0050_14_t_2012_6				
Action/Comments					
Inspector Comments: Crane appears to be in good working condition.

View of the crane above the pumps inside the building.

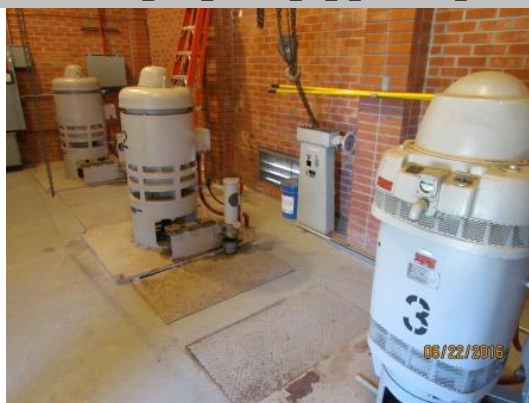
Photo 1 of 1 : ST_2016_NA0050_14_7_20160627_00019.jpg

LM Start	0.00	Rating **	A	Issue No.	7
LM End	0.00	Issue Type +	Ma	Location *	
Category	Pump Stations			GPS Latitude/Longitude	
				Start	End
Item	Pumps			38.569692 °	38.569692 °
				-121.374816 °	-121.374816 °
DWR ID	DWR_NA0050_14_t_2012_7				
Action/Comments					
Inspector Comments: Pumps appear to be properly maintained and operational.

View of the pump motors.

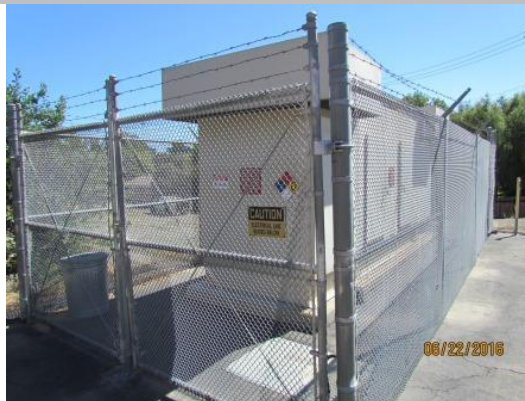
Photo 1 of 1 : ST_2016_NA0050_14_8_20160627_00020.jpg

LM Start	0.00	Rating **	A	Issue No.	8
LM End		Issue Type +	Ma	Location *	
Category	Pump Stations			GPS Latitude/Longitude	
				Start	End
Item	Power			38.569692 °	38.569692 °
				-121.374816 °	-121.374816 °
DWR ID	DWR_NA0050_14_t_2012_8				
Action/Comments					
Inspector Comments: No visible deficiencies, backup generator is on site.

View of the backup generator.

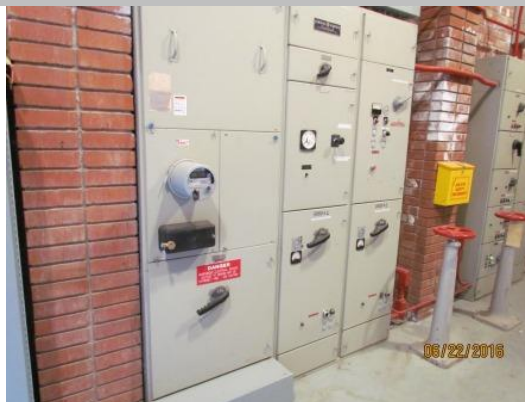
Photo 1 of 2 : ST_2016_NA0050_14_11_20160627_00021.jpg

LM Start	0.00	Rating **	A	Issue No.	11
LM End	0.00	Issue Type +	Ma	Location *	
Category	Pump Stations			GPS Latitude/Longitude	
				Start	End
Item	Pump Control Systems			38.569692 °	38.569692 °
				-121.374816 °	-121.374816 °
DWR ID	DWR_NA0050_14_t_2012_11				
Action/Comments					
Inspector Comments: Controls appear well maintained and free of corrosion.

View of the manual pump controls switches.

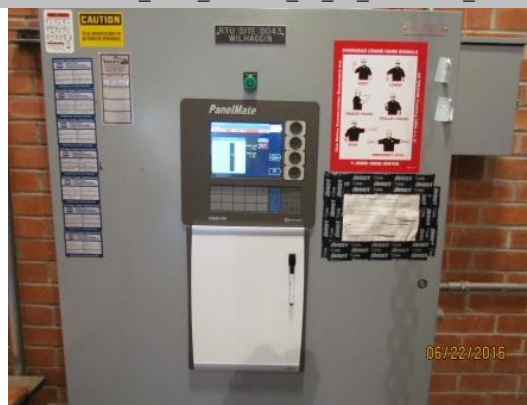
Photo 2 of 2 : ST_2016_NA0050_14_11_20160627_00022.jpg

LM Start	0.00	Rating **	A	Issue No.	11 (cont)	
LM End	0.00	Issue Type +	Ma	Location *		
Category	Pump Stations			GPS Latitude/Longitude		
				Start	End	
Item	Pump Control Systems			38.569692 °	38.569692 °	
				-121.374816 °	-121.374816 °	
DWR ID	DWR_NA0050_14_t_2012_11					
Action/Comments						
Inspector Comments: Controls appear well maintained and free of corrosion.

View of the pump controls panel.

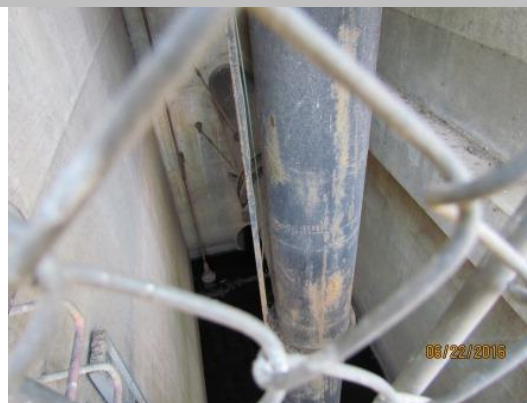
Photo 1 of 1 : ST_2016_NA0050_14_12_20160627_00023.jpg

LM Start	0.00	Rating **	A	Issue No.	12
LM End	0.00	Issue Type +	Ma	Location *	
Category	Pump Stations			GPS Latitude/Longitude	
				Start	End
Item	Sumps/Wet Well			38.569692 °	38.569692 °
				-121.374816 °	-121.374816 °
DWR ID	DWR_NA0050_14_t_2012_12				
Action/Comments					
Inspector Comments: Wet well is clear of debris.

View of the wet well.

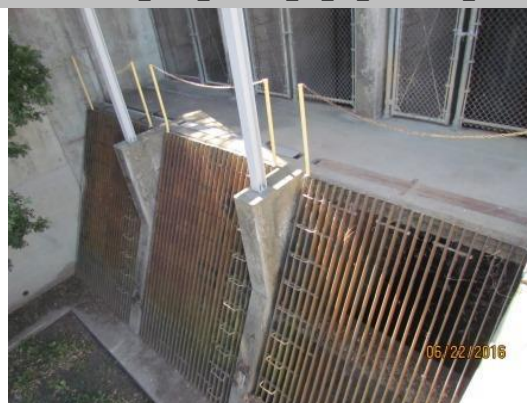
Photo 1 of 1 : ST_2016_NA0050_14_13_20160627_00024.jpg

LM Start	0.00	Rating **	A	Issue No.	13
LM End	0.00	Issue Type +	Ma	Location *	
Category	Pump Stations			GPS Latitude/Longitude	
				Start	End
Item	Trash Racks			38.569692 °	38.569692 °
				-121.374816 °	-121.374816 °
DWR ID	DWR_NA0050_14_t_2012_13				
Action/Comments					
Inspector Comments: Trash rack is in place and free of debris.

Photo shows properly maintained trash rack free of debris.

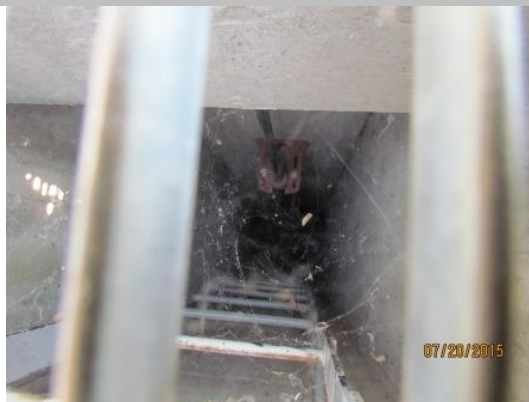
Photo 1 of 1 : ST_2016_NA0050_14_15_20160615_00011.jpg

View of the slide gate.

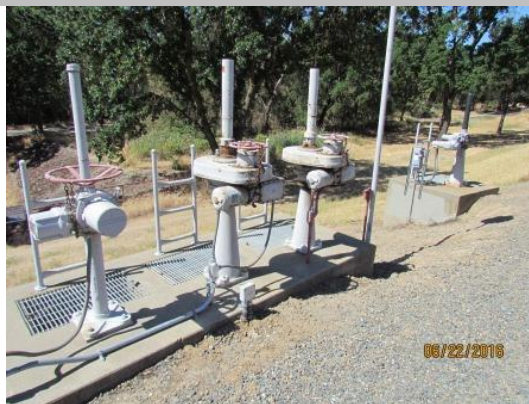
Photo 1 of 1 : ST_2016_NA0050_14_16_20160627_00025.jpg

LM Start	0.00	Rating **	A	Issue No.	16
LM End	0.00	Issue Type +	Ma	Location *	
Category	Pump Stations			GPS Latitude/Longitude	
				Start	End
Item	Electric Gate Operators			38.569692 °	38.569692 °
				-121.374816 °	-121.374816 °
DWR ID	DWR_NA0050_14_t_2012_16				
Action/Comments					
Inspector Comments: Electric gate operators appear to be properly maintained and in proper working order.

View of the gate controls.

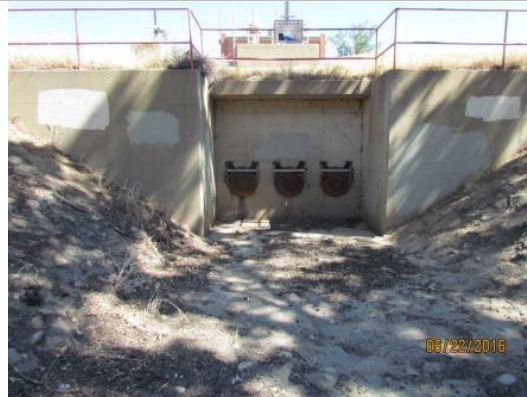
Photo 1 of 1 : ST_2016_NA0050_14_19_20160627_00026.jpg

LM Start	0.00	Rating **	A	Issue No.	19
LM End	0.00	Issue Type +	Ma	Location *	
Category	Pump Stations			GPS Latitude/Longitude	
				Start	End
Item	Flap Gates			38.569692 °	38.569692 °
				-121.374816 °	-121.374816 °
DWR ID	DWR_NA0050_14_t_2012_19				
Action/Comments					
Inspector Comments: Flap gates are visible and appear to be in working order, there was no flow to test for leakage.

View of the flap gates.

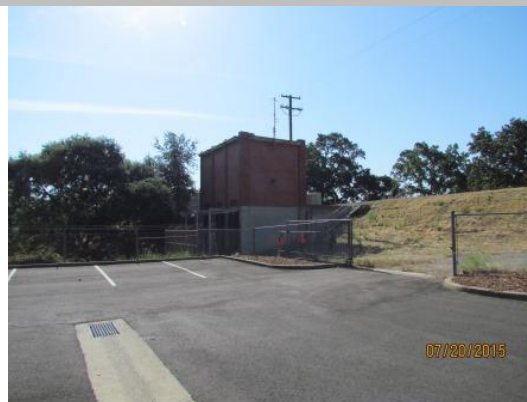
Photo 1 of 1 : ST_2016_NA0050_14_21_20160615_00014.jpg

View of the security fencing.

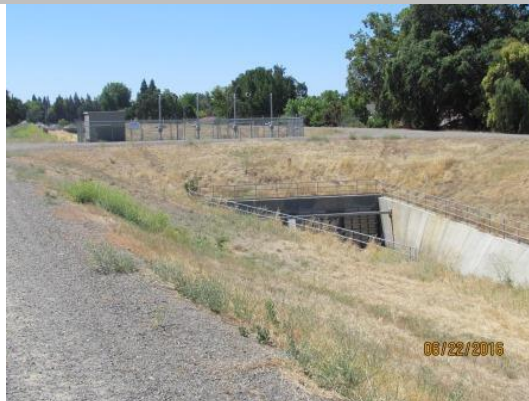
Photo 1 of 1 : ST_2016_NA0050_220_1_20160623_00014.jpg

General view of the closure structure, facing upstream.

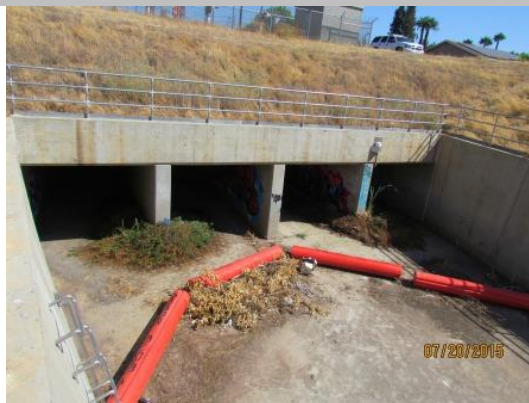
Photo 1 of 3 : ST_2016_NA0050_220_7_20160615_00001.jpg

View of the structure inlet.

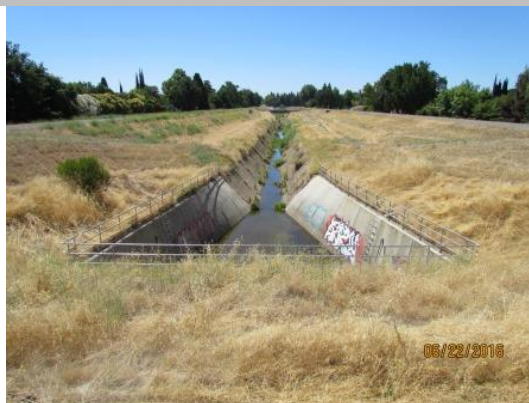
Photo 2 of 3 : ST_2016_NA0050_220_7_20160623_00008.jpg

View of the inlet channel.

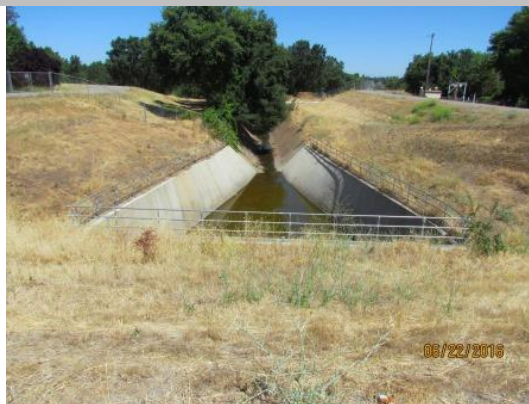
Photo 3 of 3 : ST_2016_NA0050_220_7_20160623_00009.jpg

View of the outlet channel.

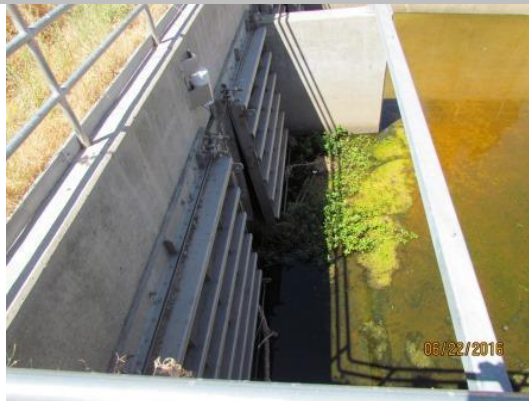
Photo 1 of 2 : ST_2016_NA0050_220_11_20160623_00010.jpg

View of a flap gate with debris propping the gate open.

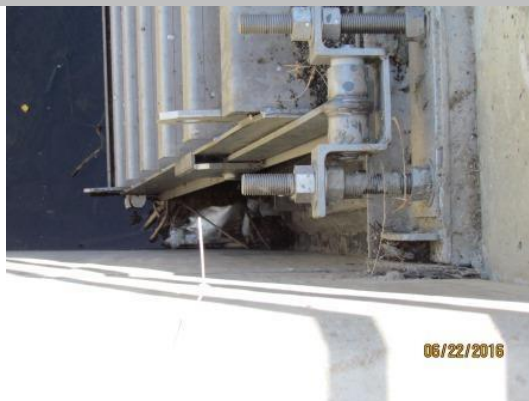
Photo 2 of 2 : ST_2016_NA0050_220_11_20160623_00011.jpg

LM Start	0.00	Rating **	M	Issue No.	11 (cont)
LM End	0.00	Issue Type +	Ma	Location *

Another view of a flap gate with debris propping the gate open.

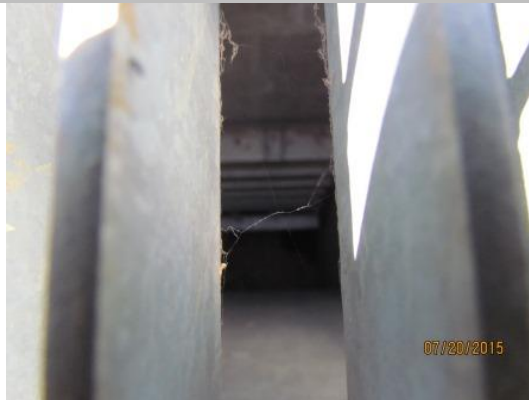
Photo 1 of 1 : ST_2016_NA0050_220_12_20160615_00005.jpg

LM Start	0.00	Rating **	A	Issue No.	12
LM End	0.00	Issue Type +	Ma	Location *	
Category	Structures & Concrete Lined Channels			GPS Latitude/Longitude	
				Start	End
Item	Sluice/Slide Gates			38.569898 °	38.569898 °
				-121.353360 °	-121.353360 °
DWR ID	DWR_NA0050_220_t _ 2014_12				
Action/Comments					
Inspector Comments: Slide gates appear to be in proper working order.

View of a slide gate.

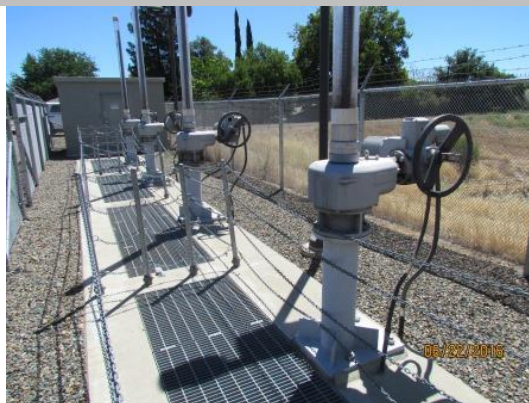
Photo 1 of 1 : ST_2016_NA0050_220_13_20160623_00012.jpg

LM Start	0.00	Rating **	A	Issue No.	13
LM End	0.00	Issue Type +	Ma	Location *	
Category	Structures & Concrete Lined Channels			GPS Latitude/Longitude	
				Start	End
Item	Electric Gate Operators			38.569898 °	38.569898 °
				-121.353360 °	-121.353360 °
DWR ID	DWR_NA0050_220_t_2014_13				
Action/Comments					
Inspector Comments: Electric gate operators appear to be in working condition with manual controls installed.

View of the gate mechanism controls.

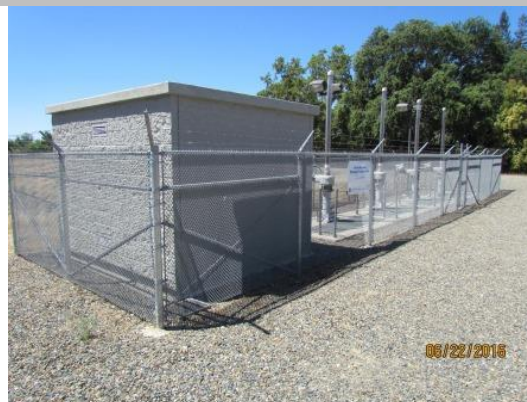
Photo 1 of 1 : ST_2016_NA0050_220_18_20160623_00013.jpg

View of the security fencing around the facility.
